# Norcure Chloride Removal Systems

## Corrosion Overview

### Corrosion Process and Testing

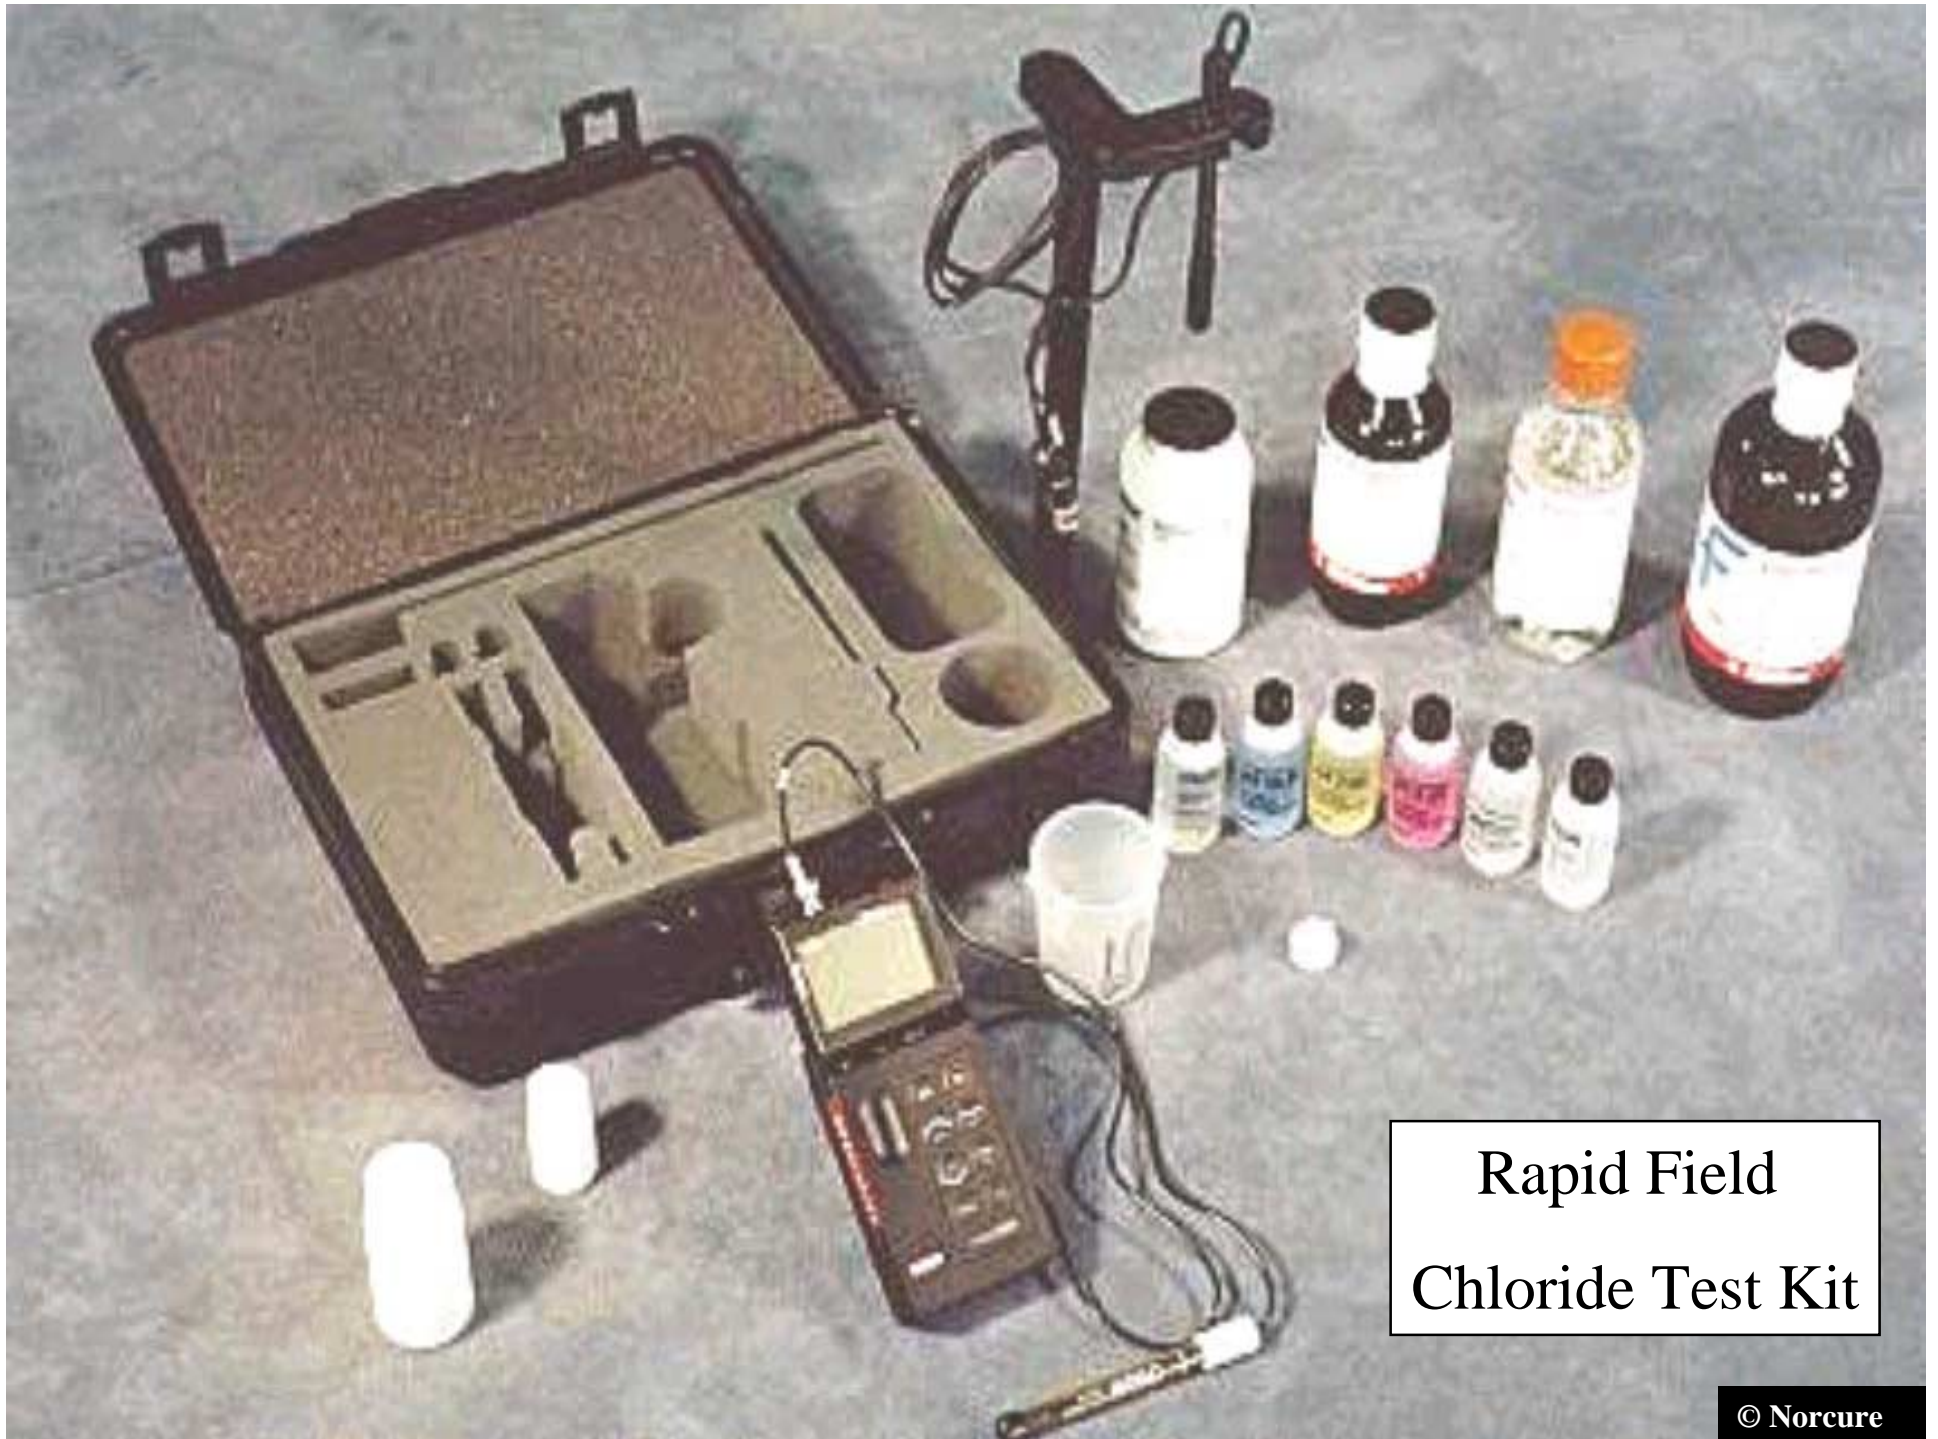
Rapid Field  
Chloride Test Kit

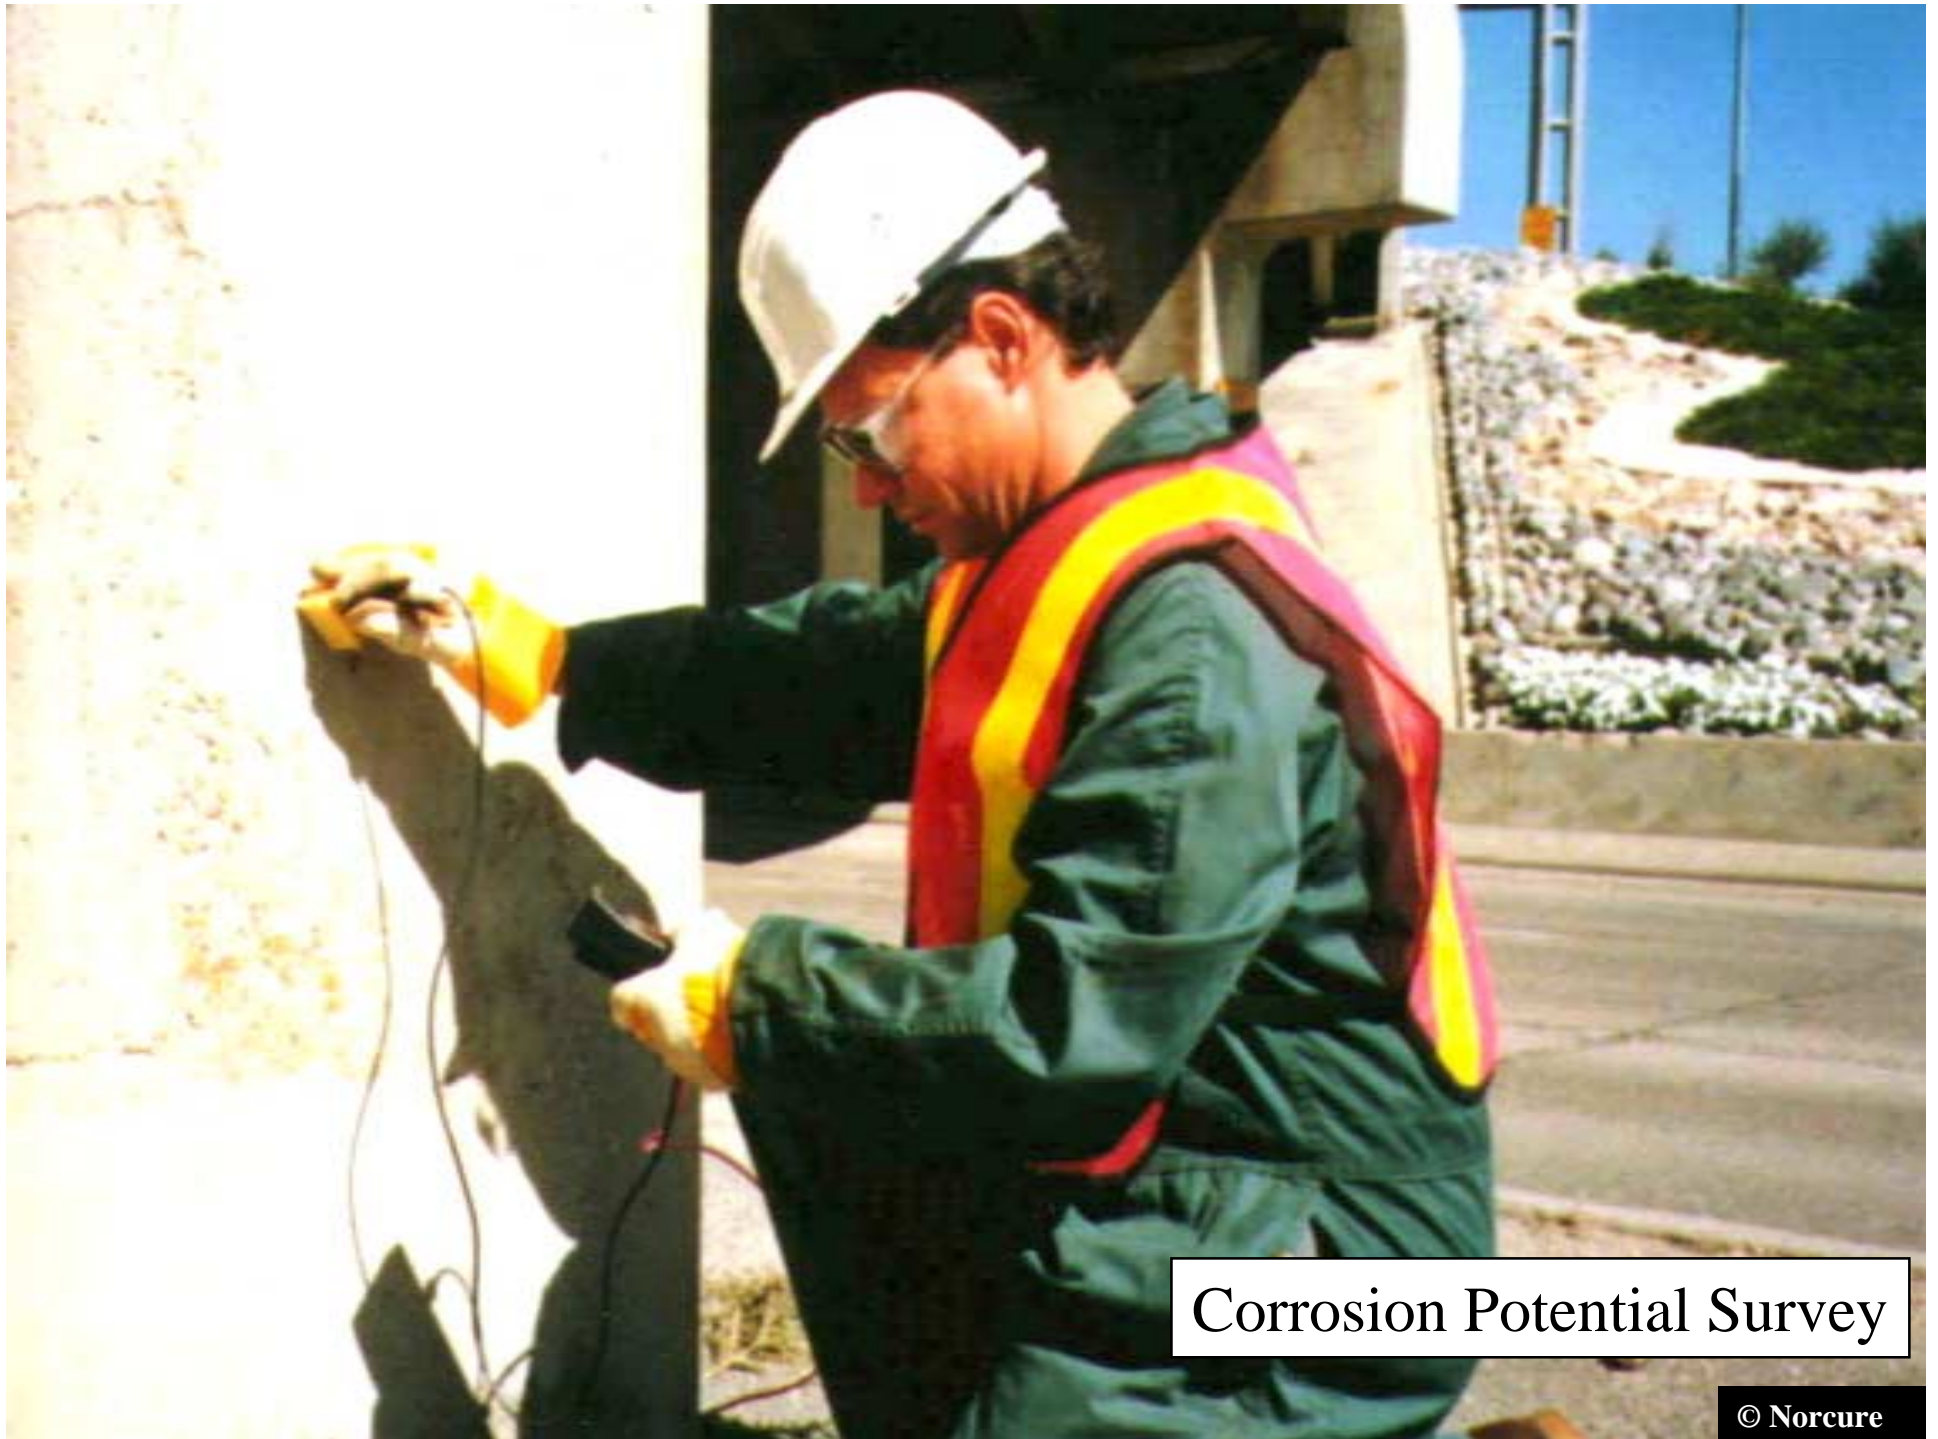
Corrosion Potential Survey

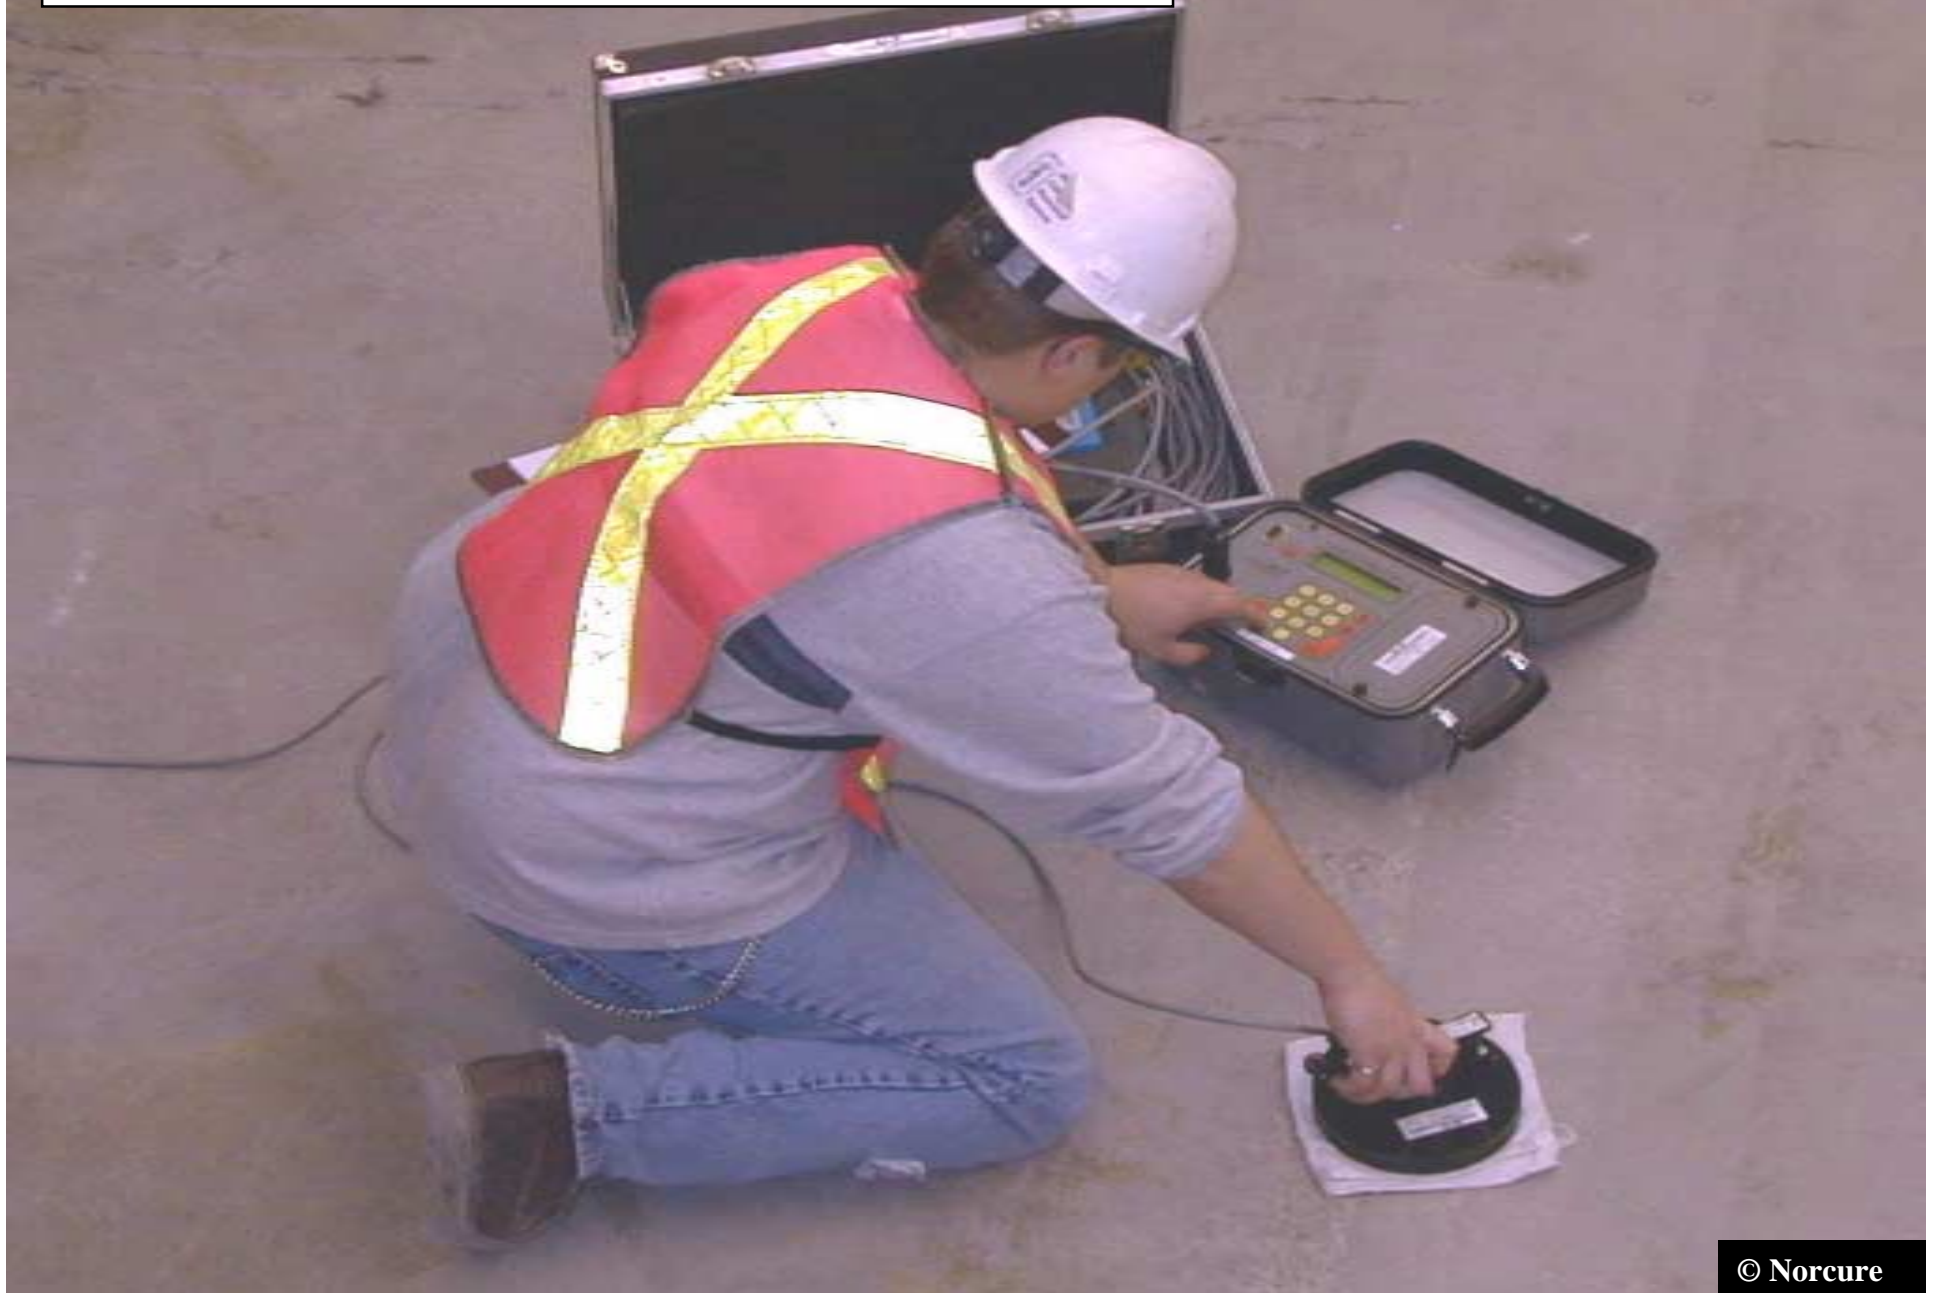
## Measuring Corrosion Rate with GECOR 6

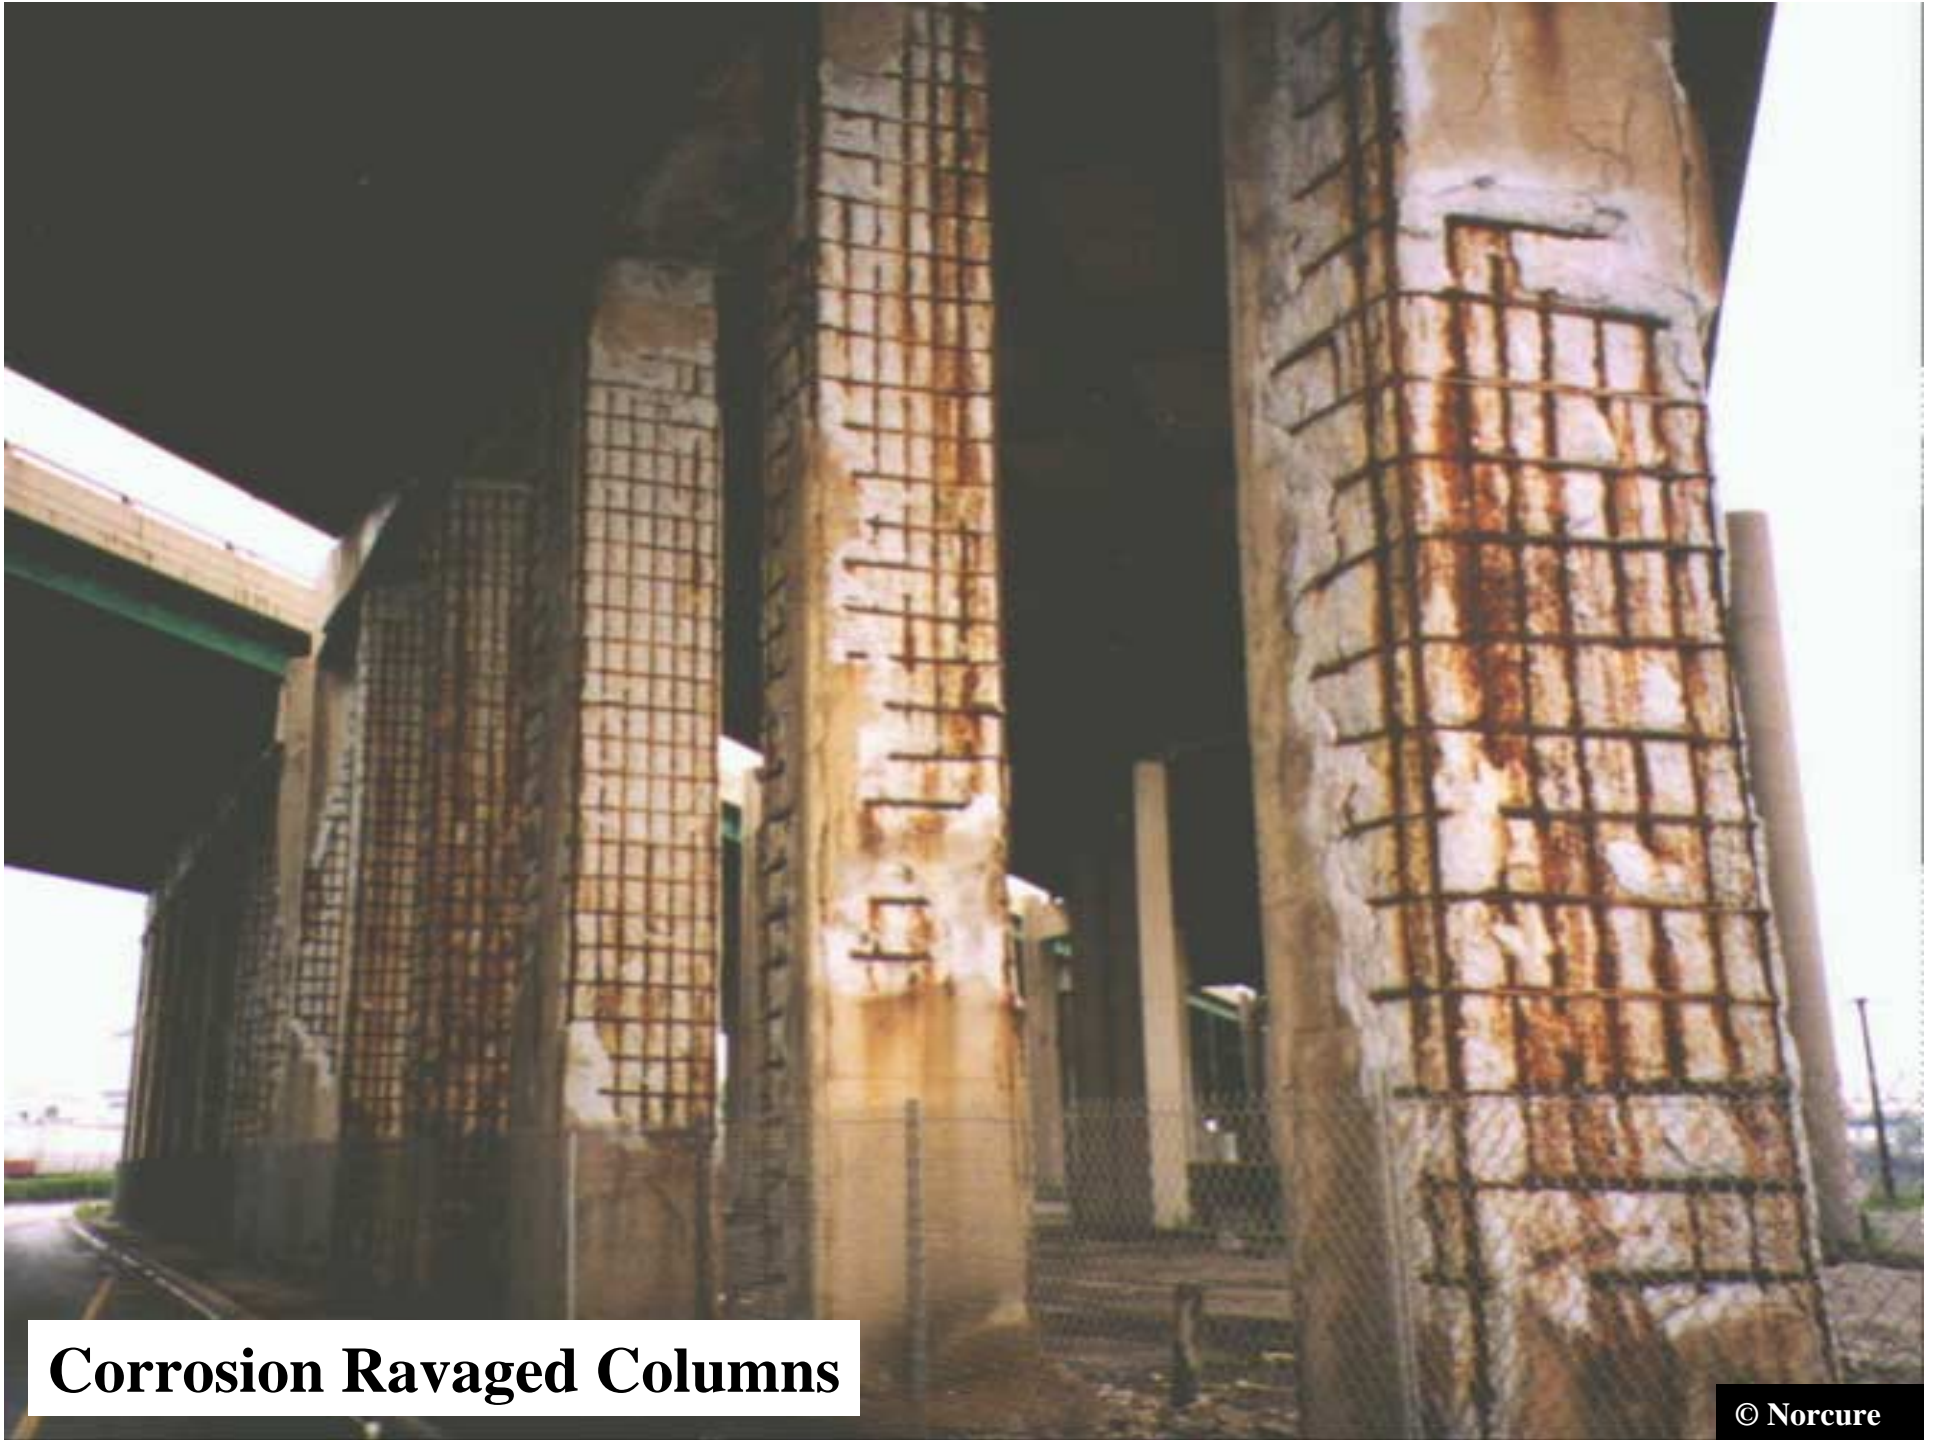
**Corrosion Ravaged Columns**

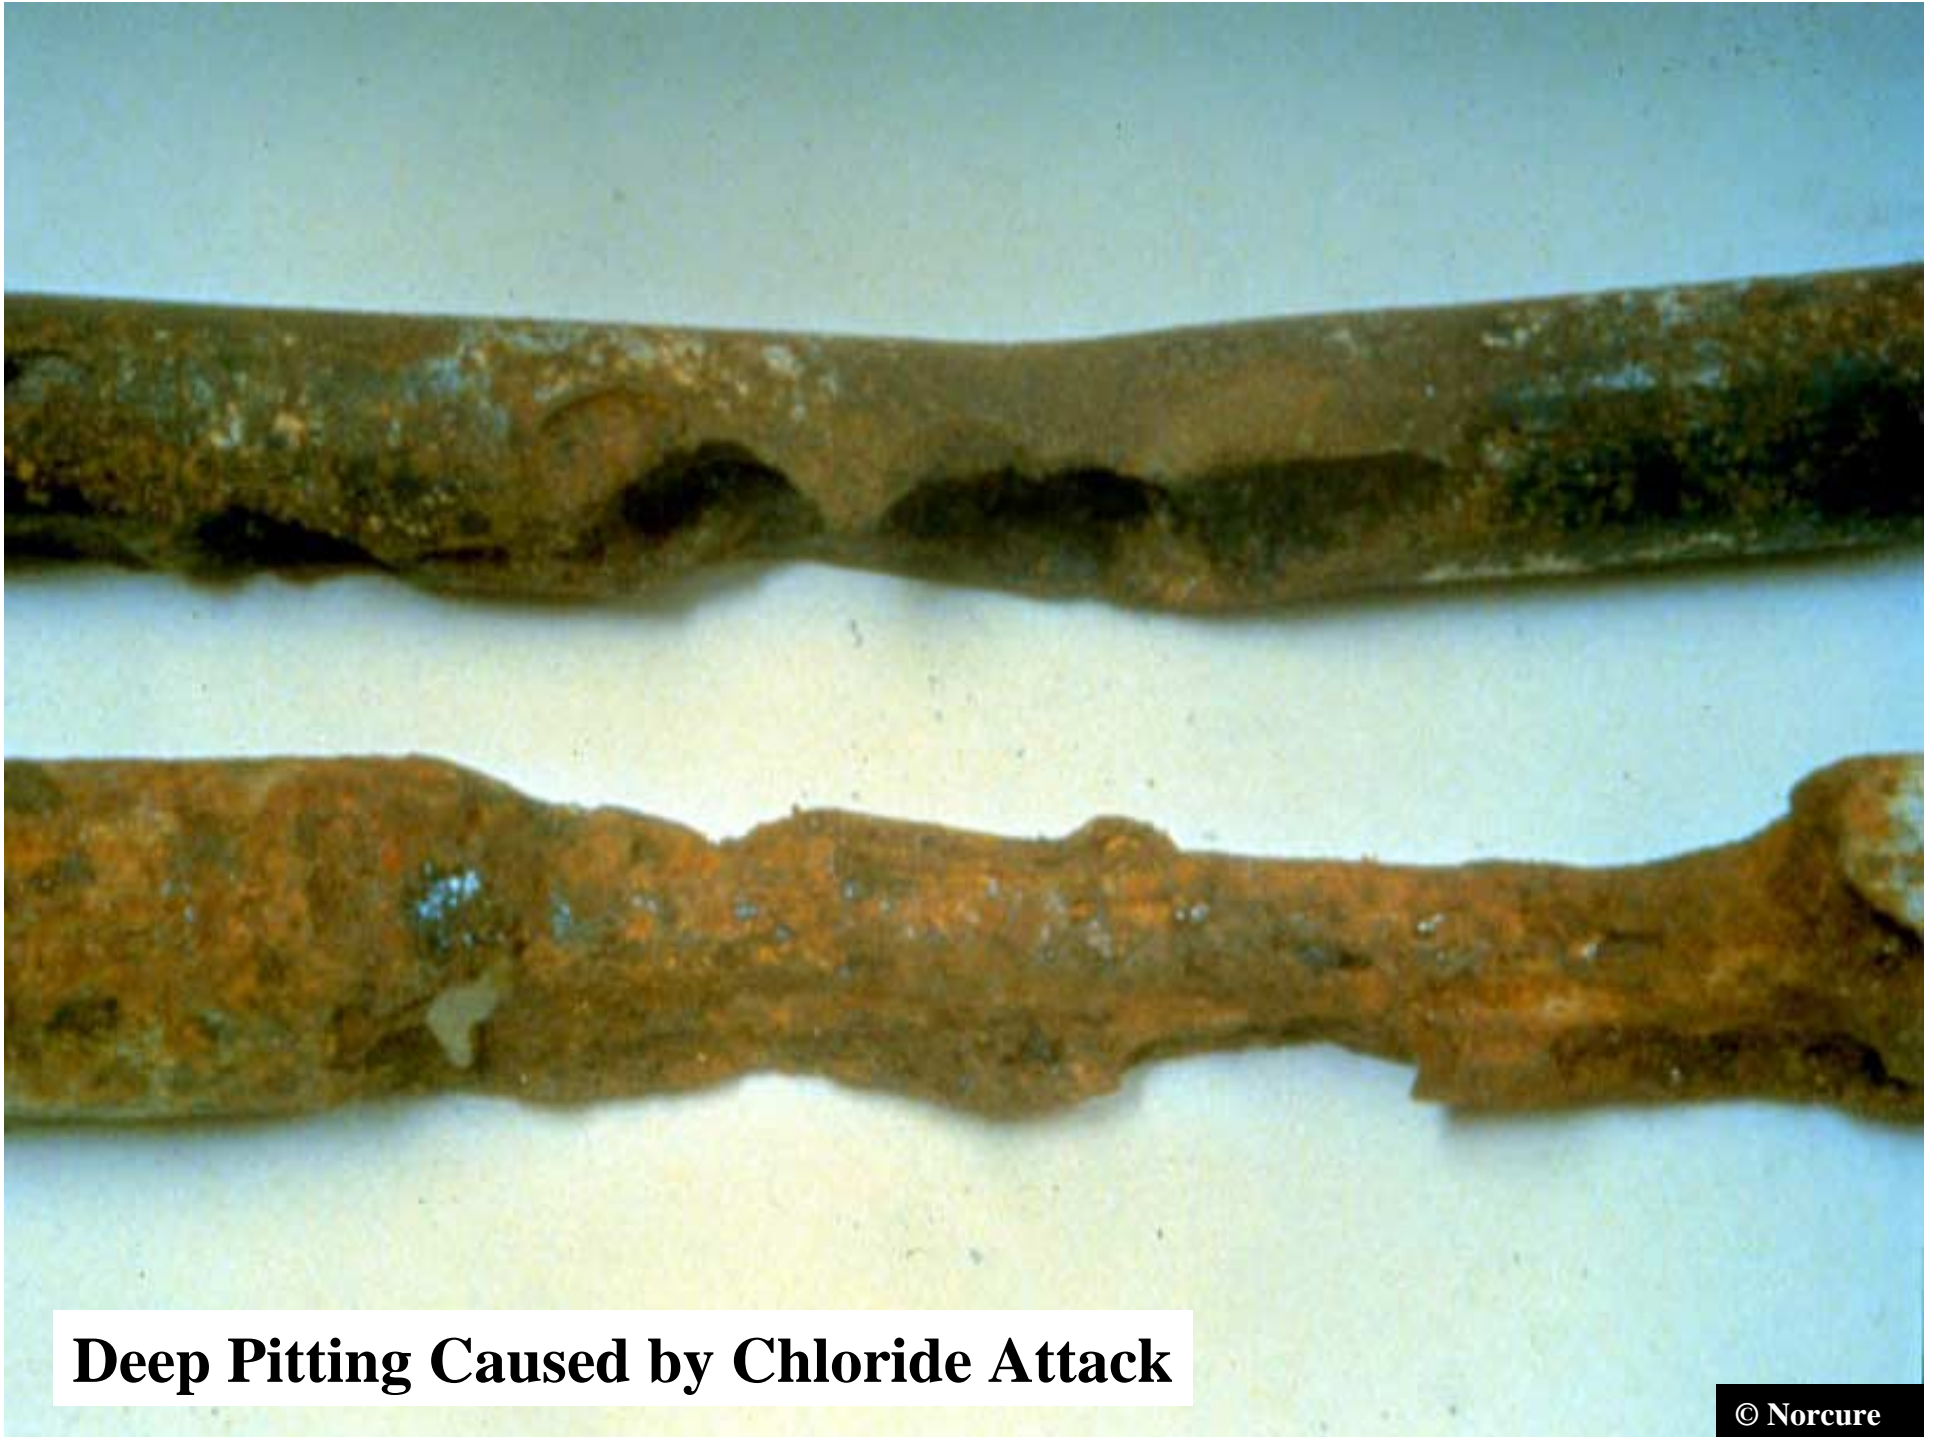
**Deep Pitting Caused by Chloride Attack**

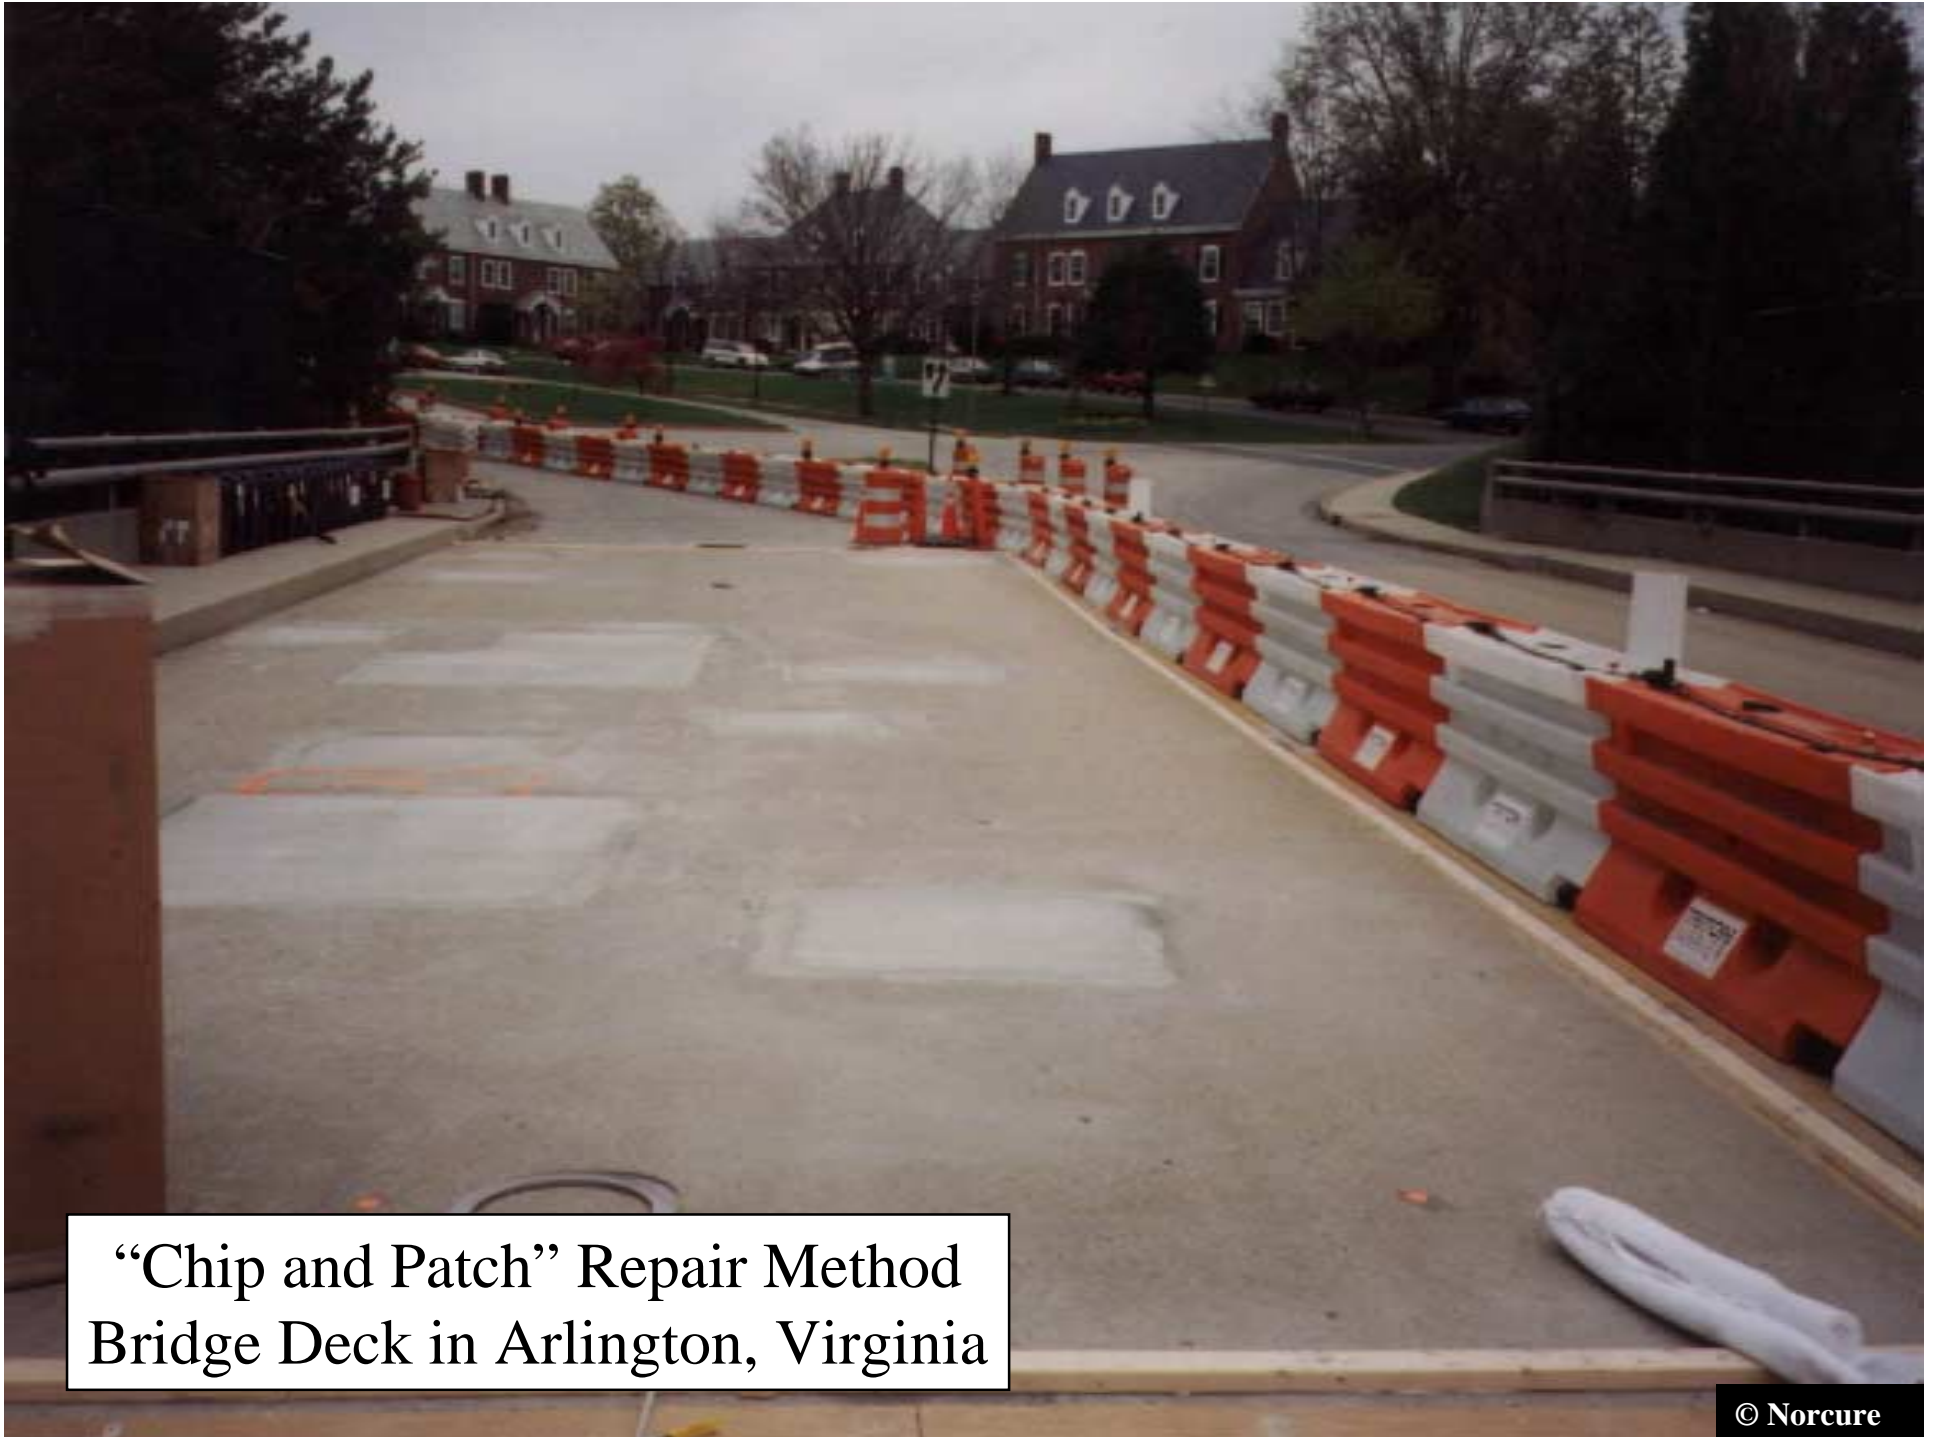
“Chip and Patch” Repair Method  
Bridge Deck in Arlington, Virginia

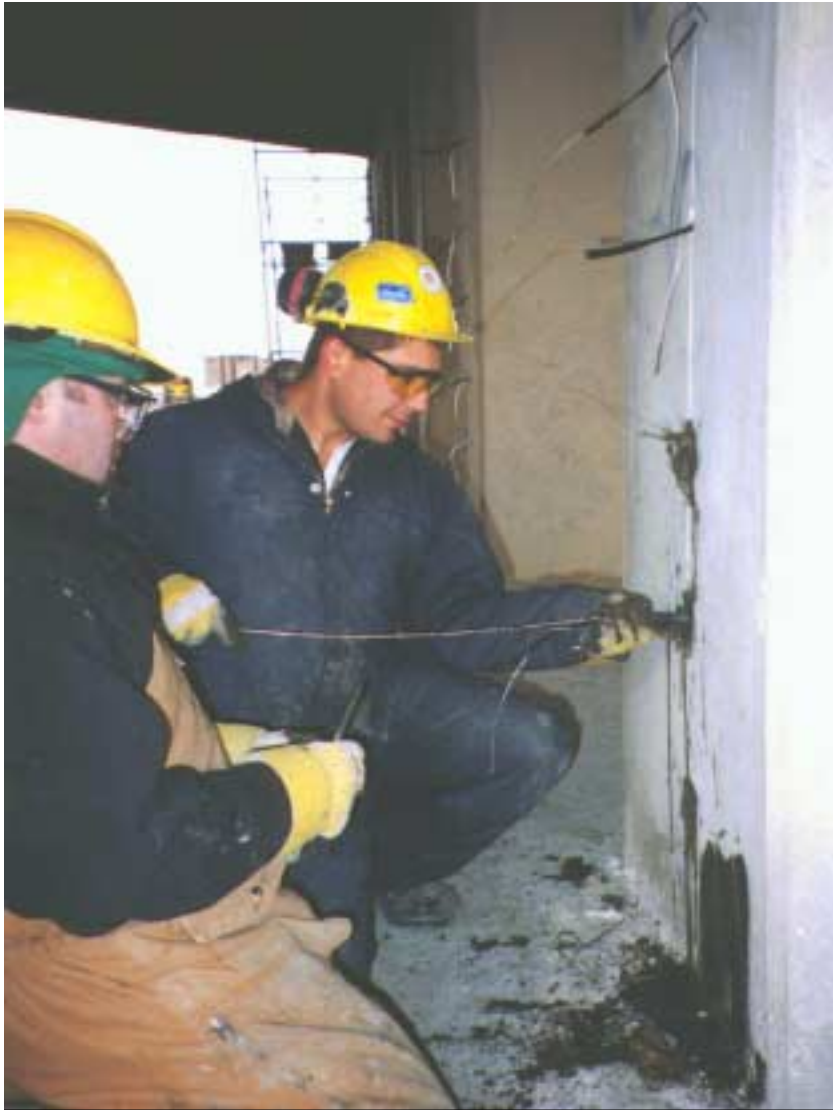
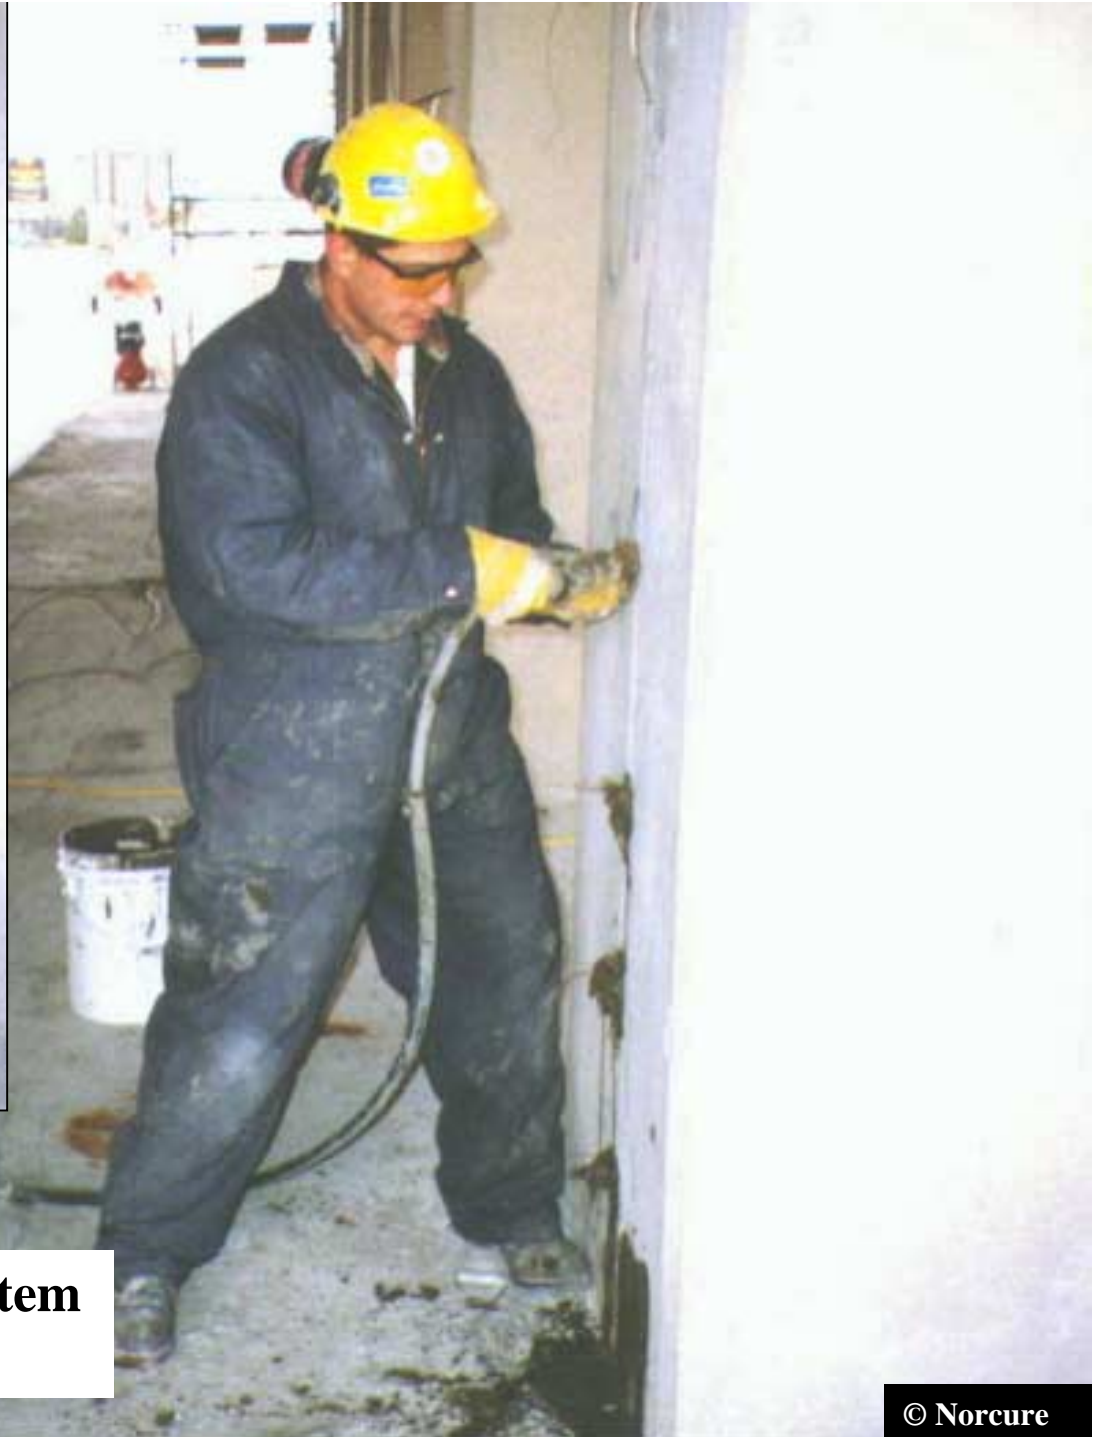
**Installation of Discrete Anode System  
Winnipeg, Manitoba**

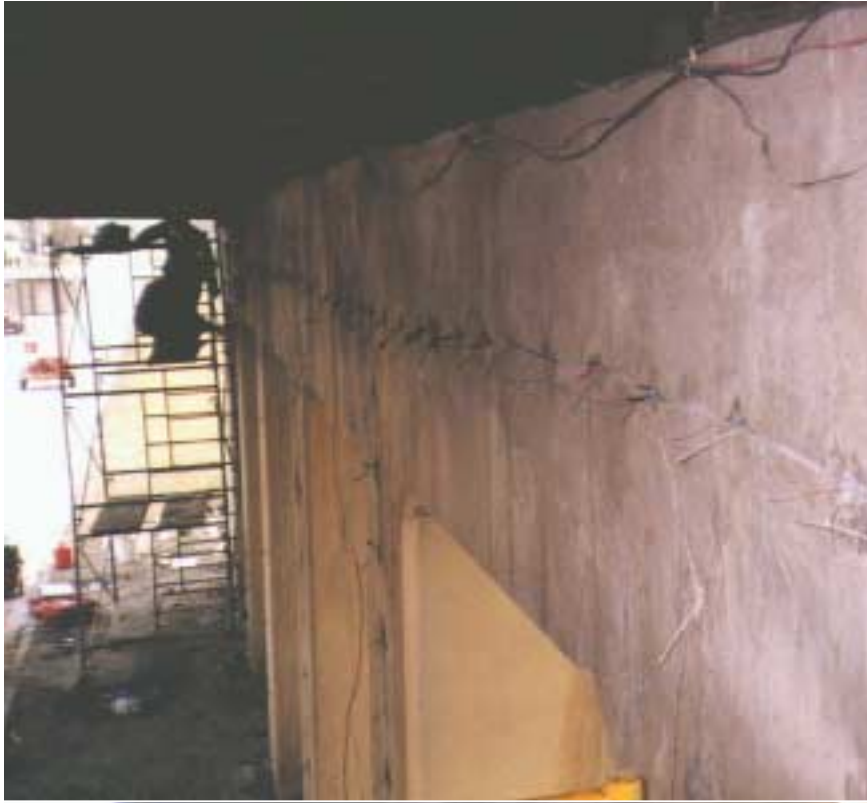
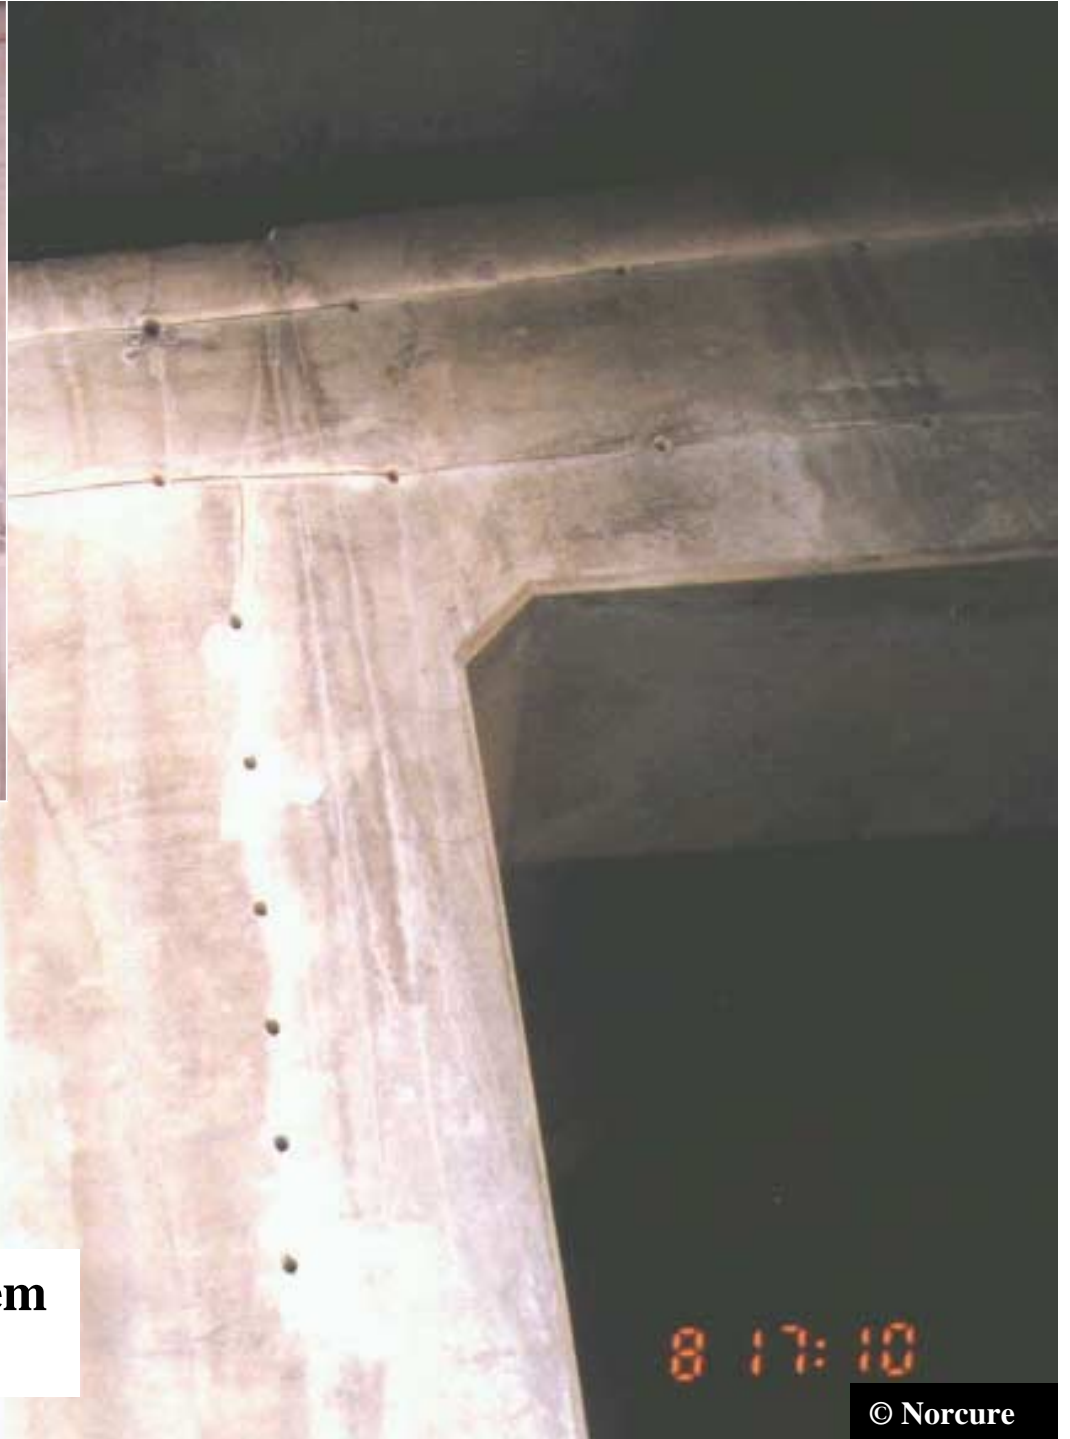
**Installation of Discrete Anode System  
Winnipeg, Manitoba**
