# Norcure Chloride Removal Systems

## Corrosion Overview

### Corrosion Process and Testing

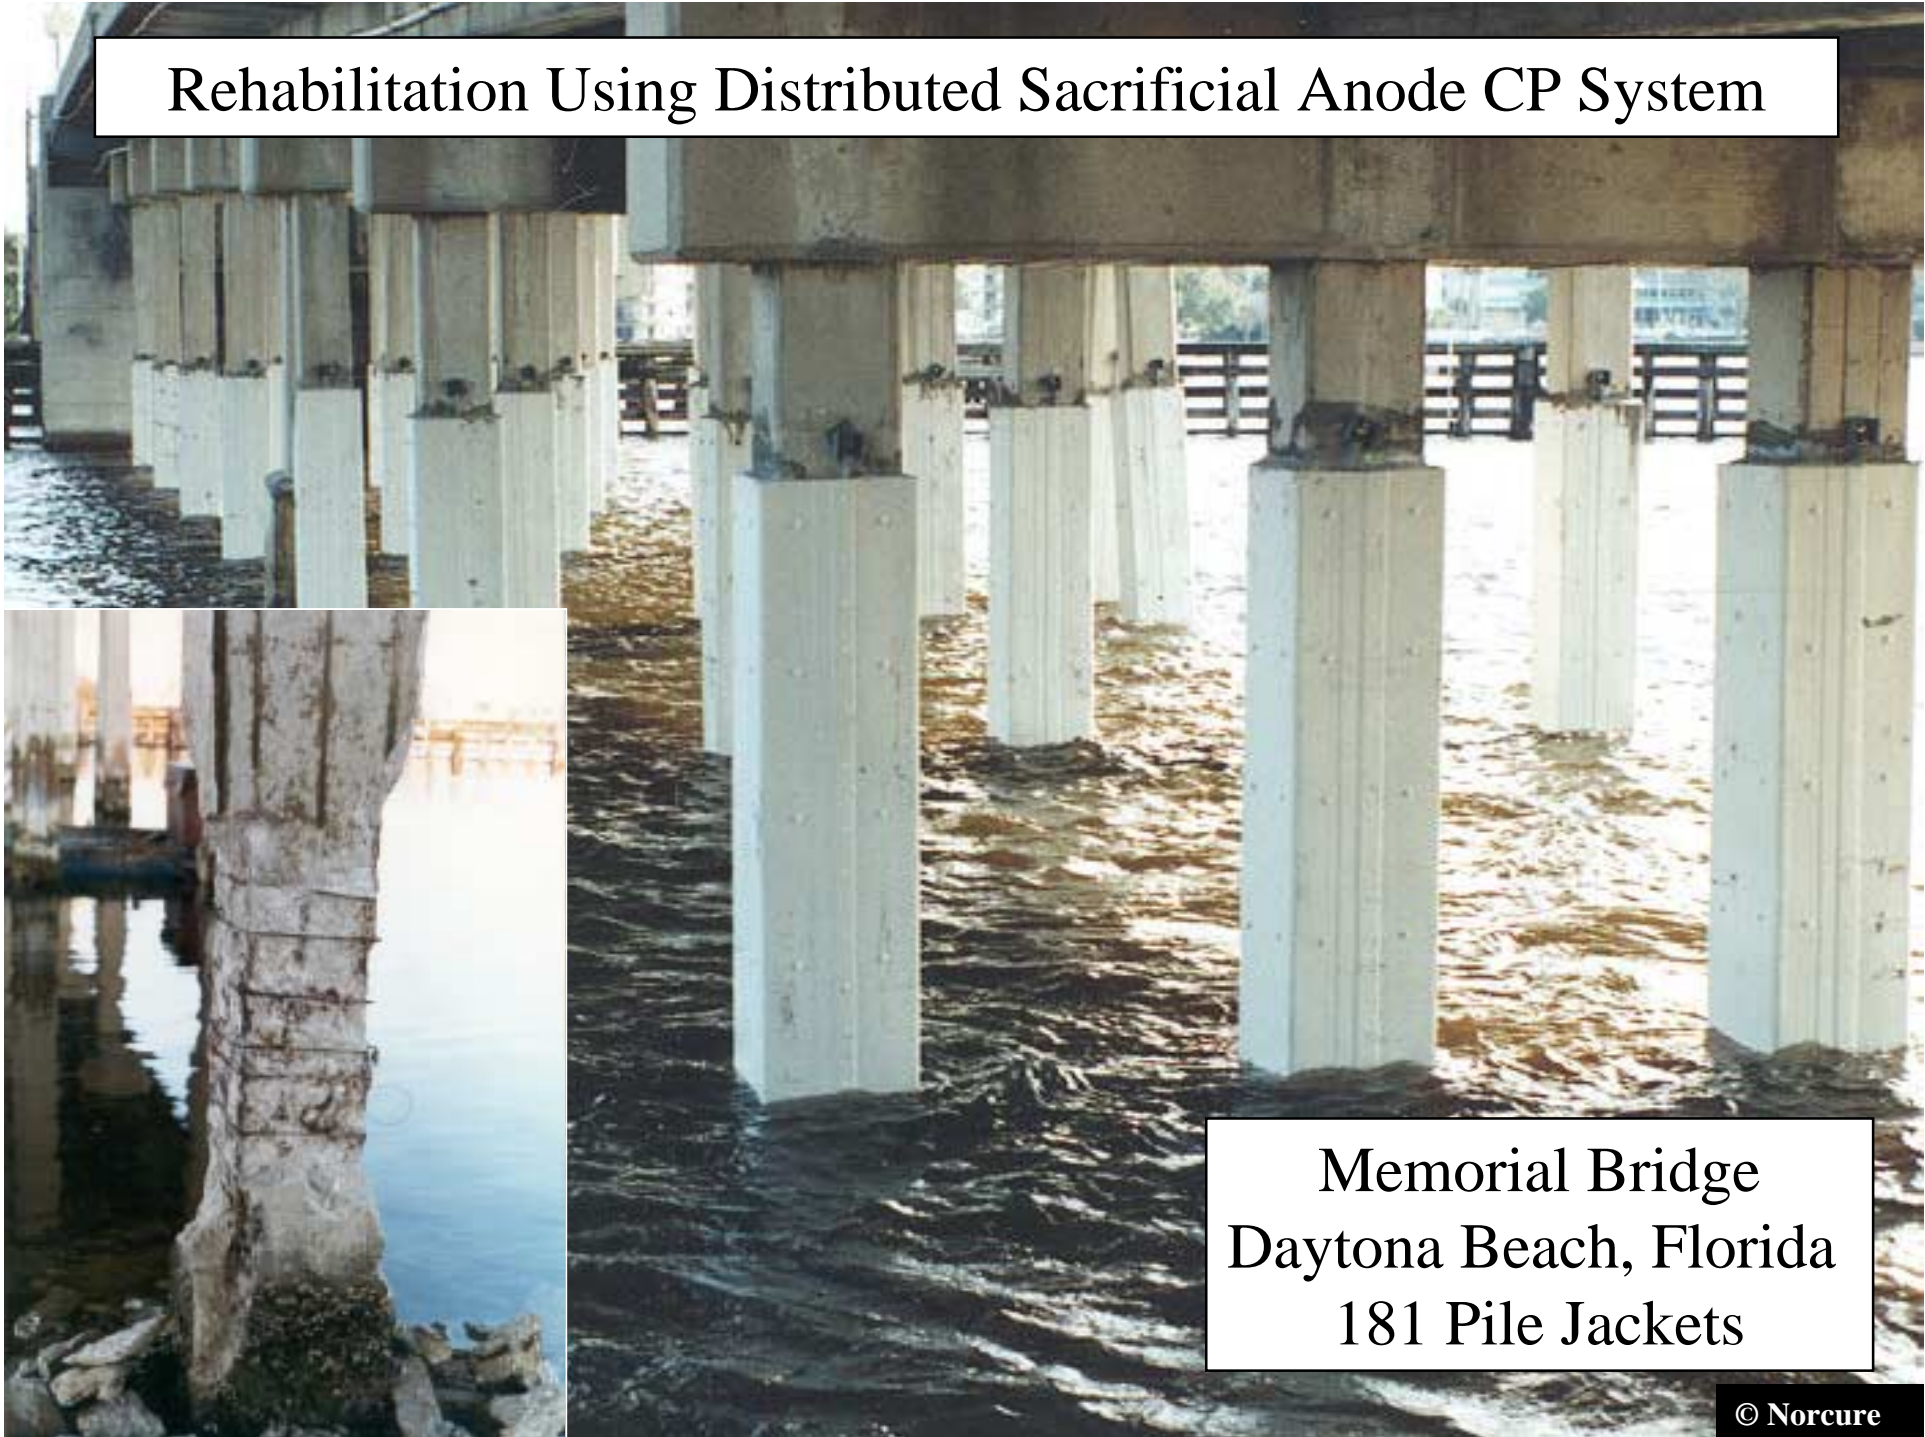
# Rehabilitation Using Distributed Sacrificial Anode CP System

Memorial Bridge  
Daytona Beach, Florida  
181 Pile Jackets

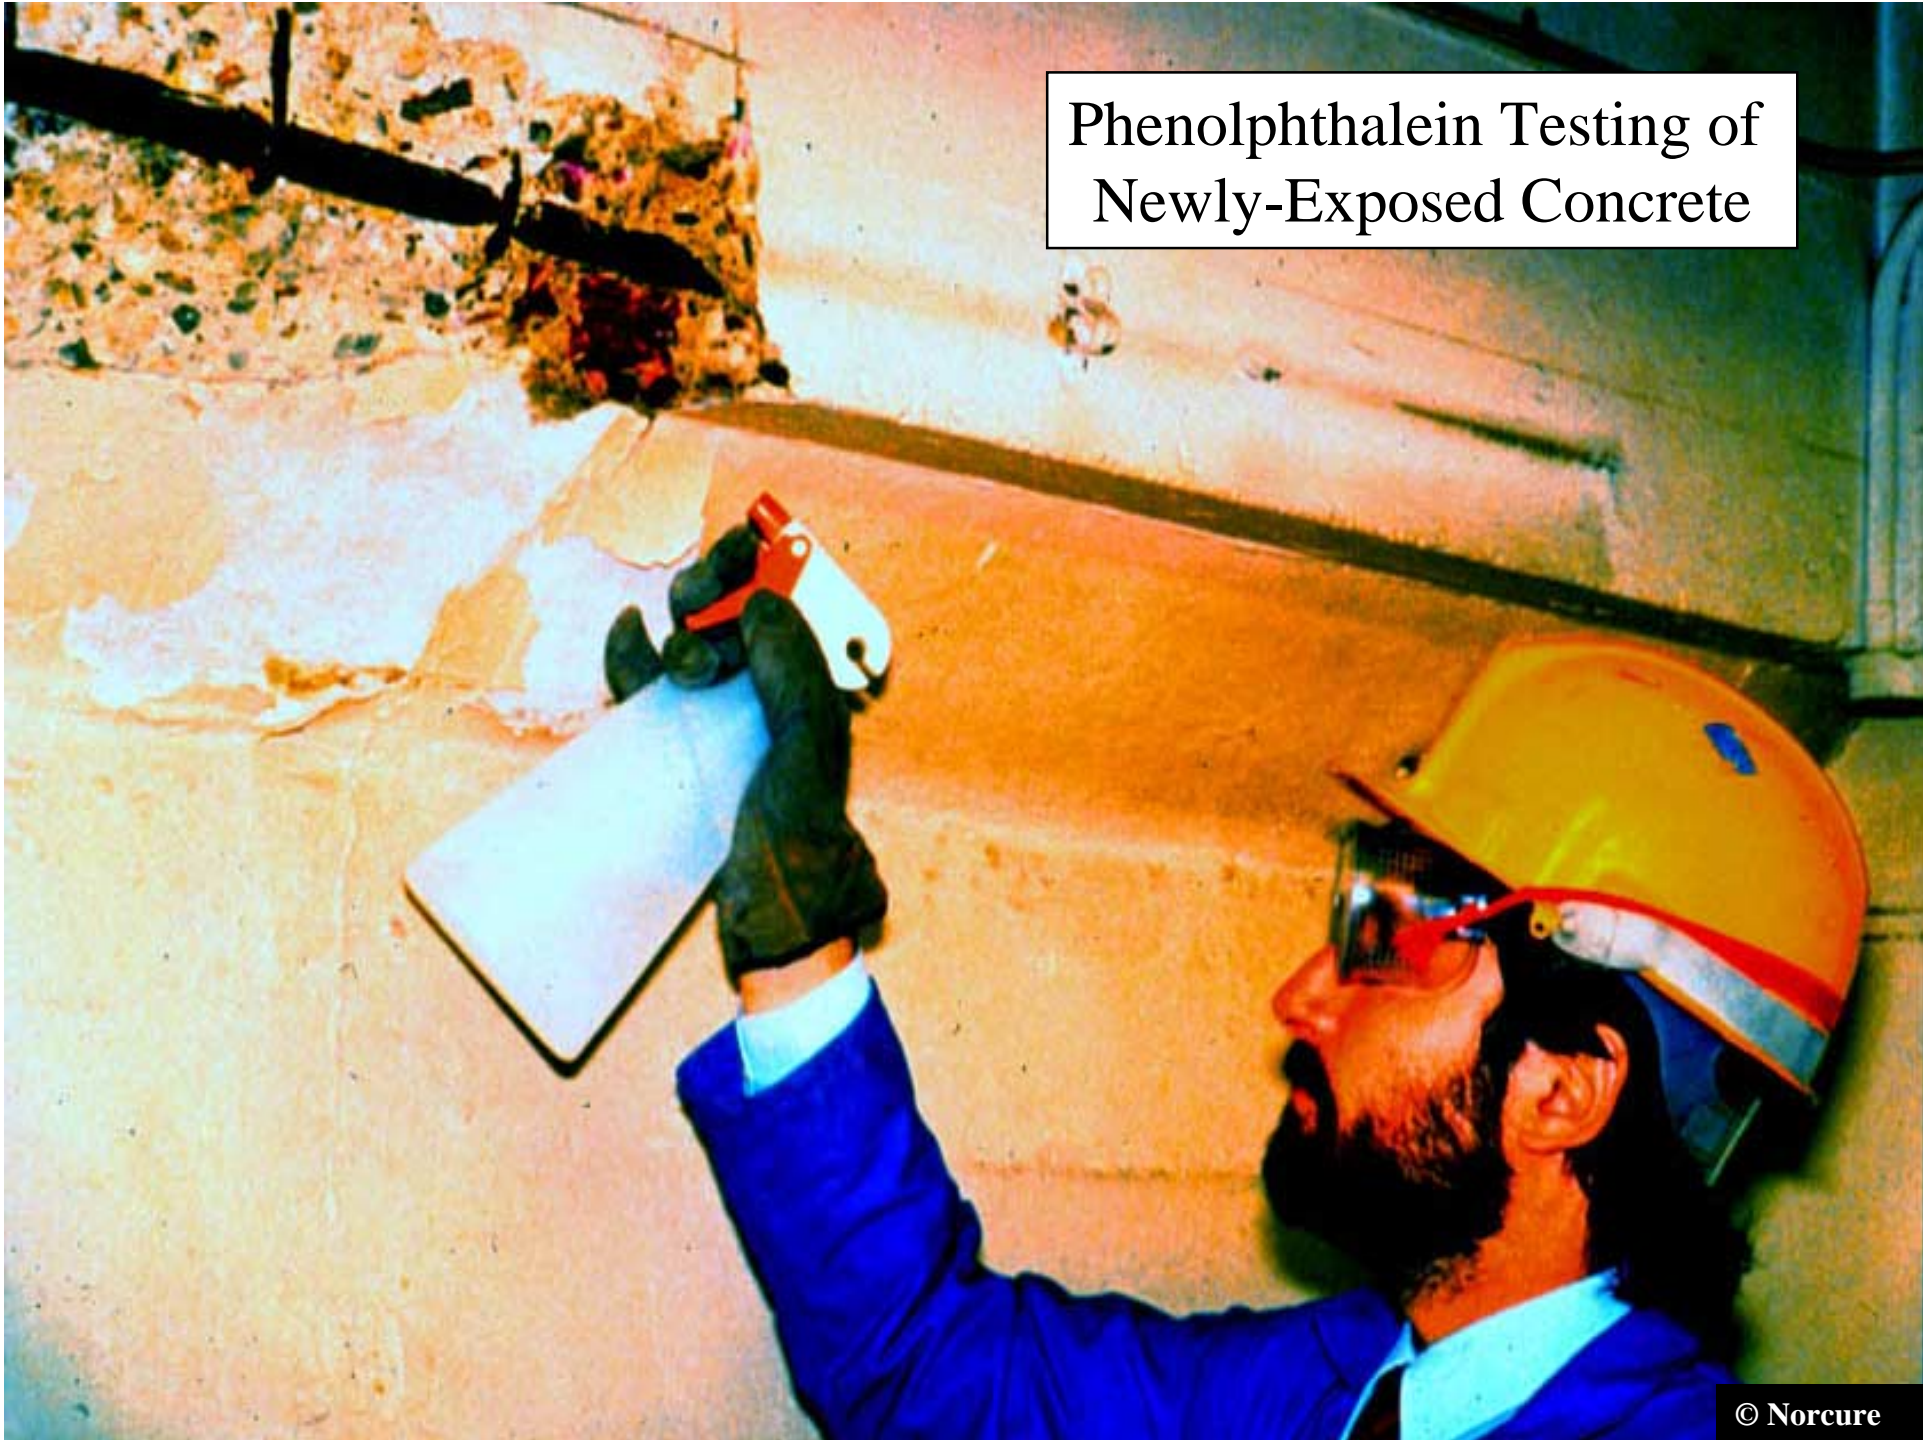
Phenolphthalein Testing of  
Newly-Exposed Concrete

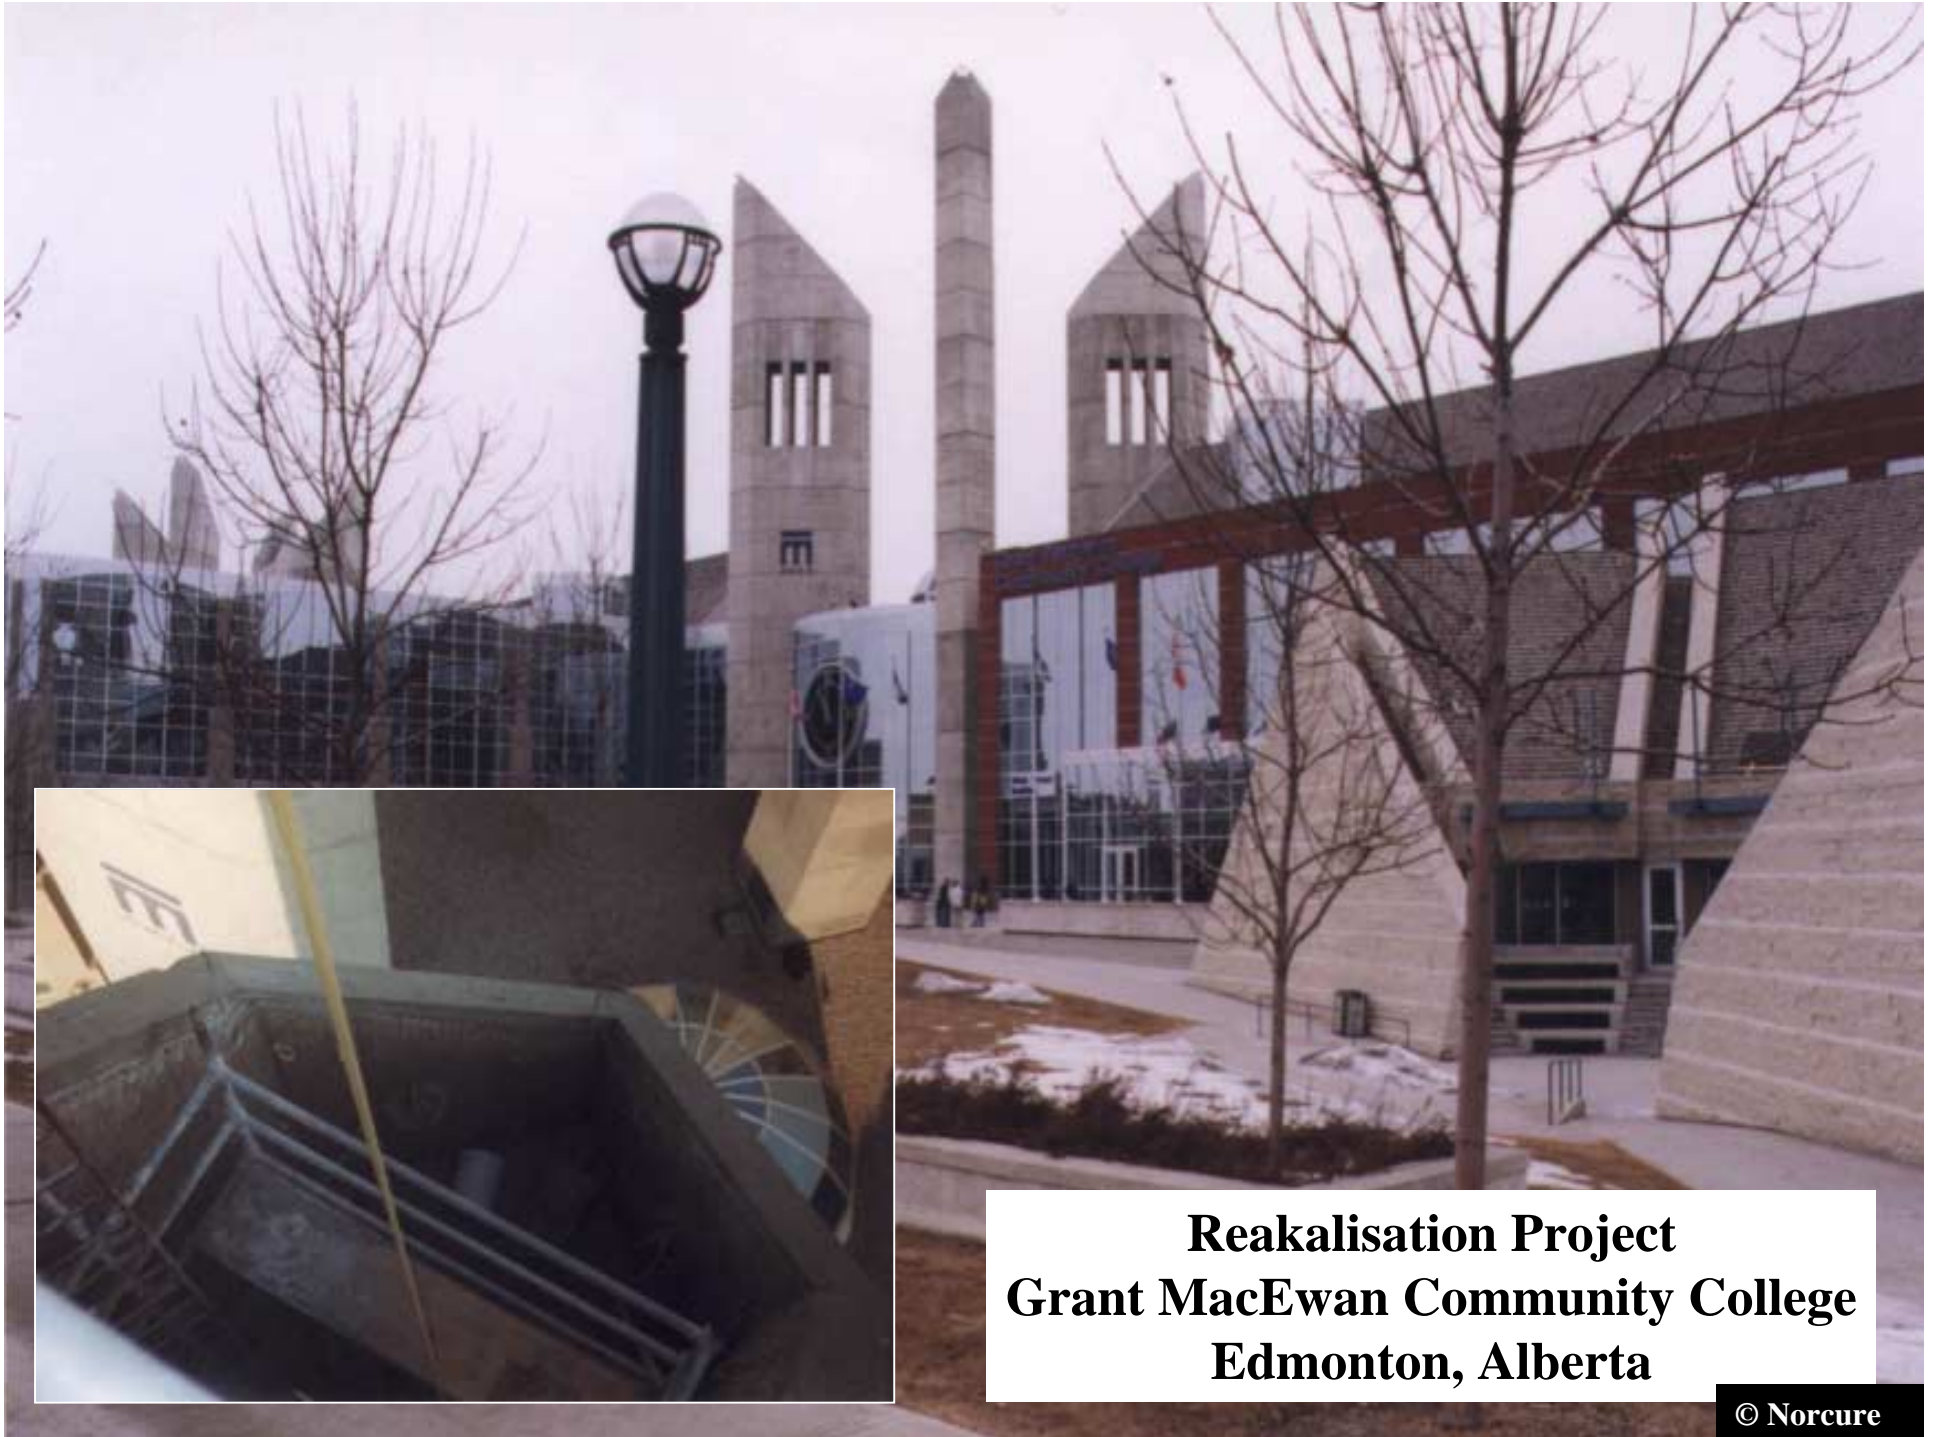
**Reakalisation Project  
Grant MacEwan Community College  
Edmonton, Alberta**
