Norcure Chloride Removal Systems

Galvashield XP Embedded Galvanic Anodes

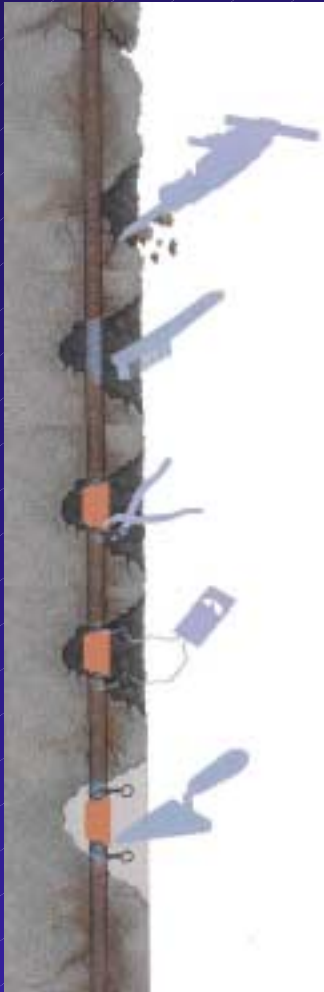
Embedded Galvanic Anode Installation

- ◆ Concrete is removed from in and around the steel reinforcement
- ◆ The reinforcement should be cleaned appropriately
- ◆ The anode unit should be positioned and attached to clean reinforcement using the tie wires and tightened
- ◆ The continuity between the tie wires and the cleaned reinforcing steel should be confirmed
- ◆ With the anode(s) now in position, the repair can be completed using the appropriate repair materials

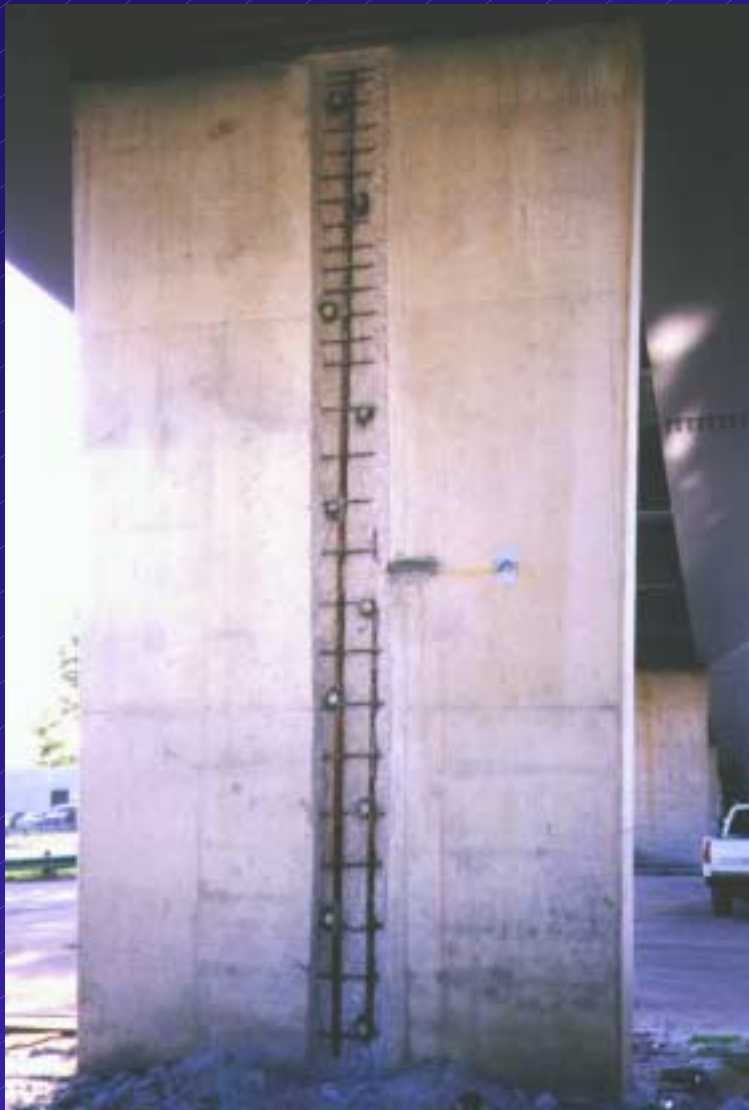
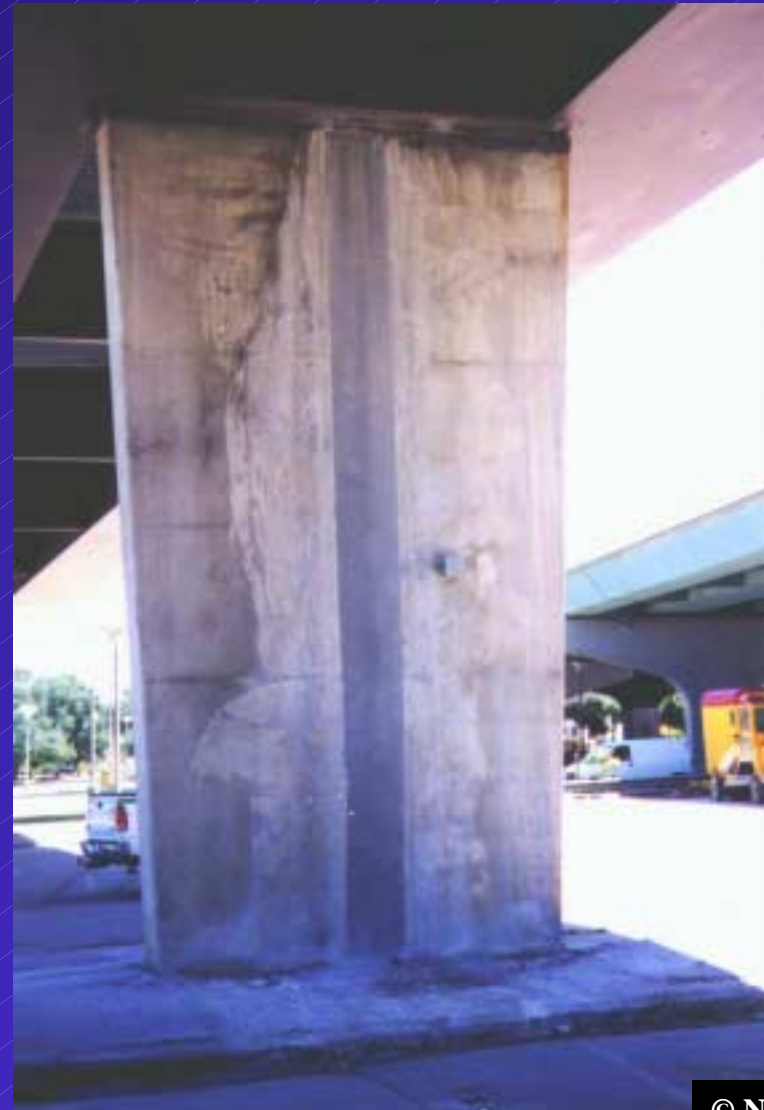
I-480 Pier 2B in Omaha, Nebraska, USA

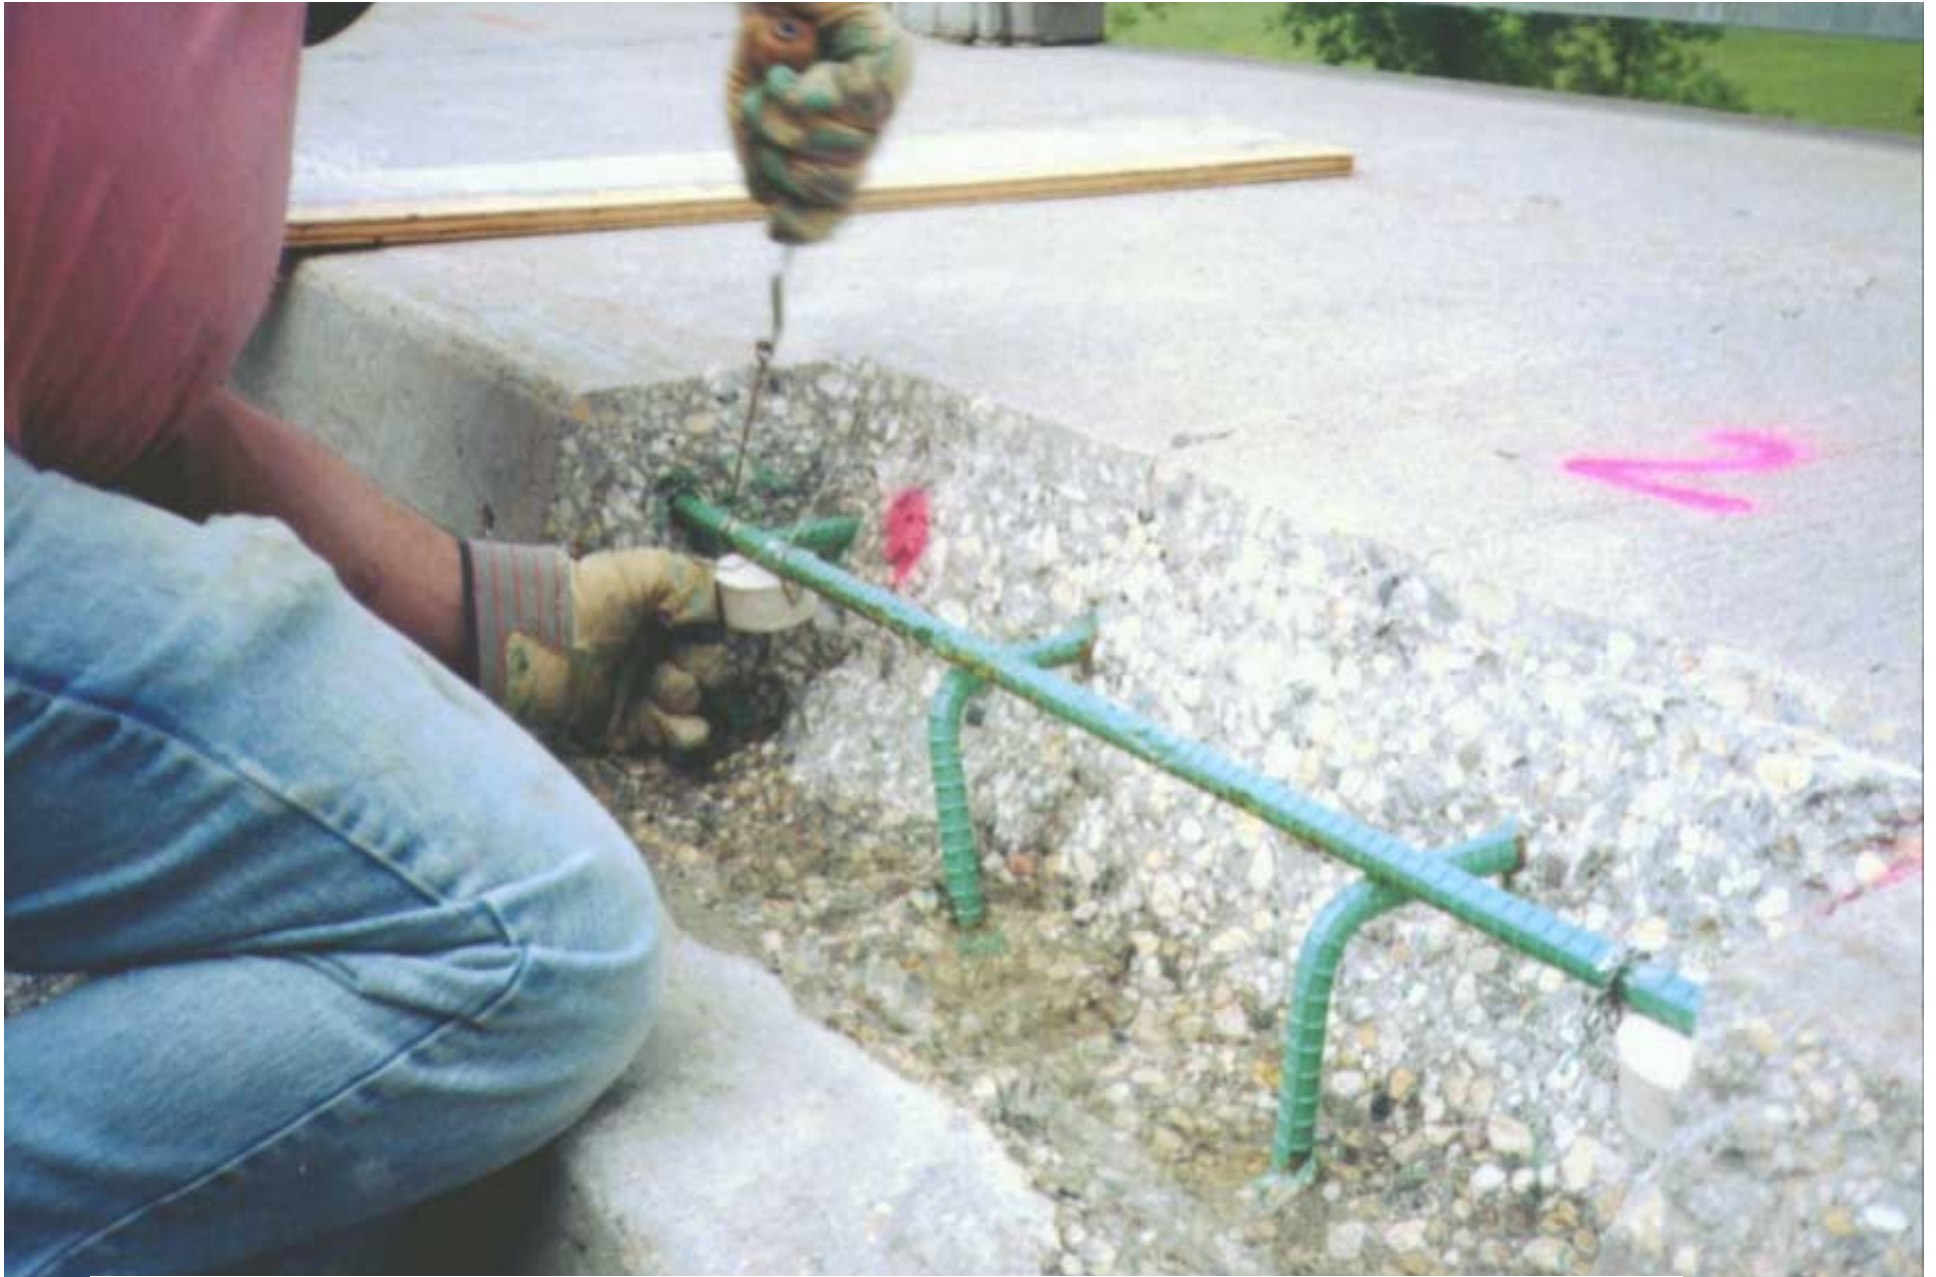
Quick and Easy Installation
